## DJI FINDS FIRMWARE BUG CAUSING SPONTANIOUS S800 SYSTEM FAILURE

*Research and testing confirms zero faults with S800 air frame – error found in compass firmware*

DJI Innovations Technology Co. Ltd.

OCT 19th, 2012

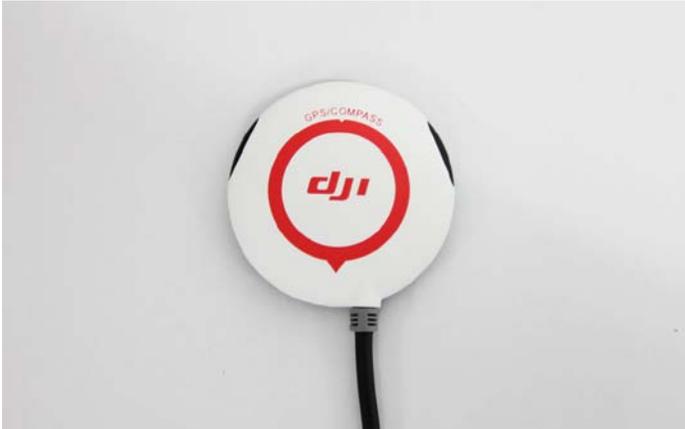
Old GPS Module (OKAY TO FLY):

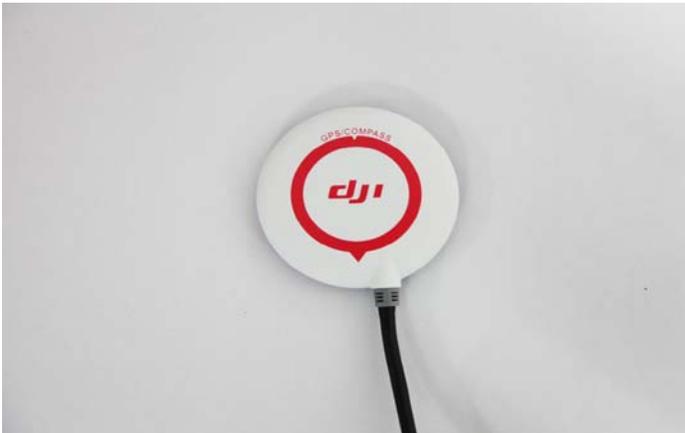
DJI, one of the world's leading developers and manufacturers in UAV systems, today announced a voluntary recall of all WooKong-M GPS compasses purchased after June 15th, 2012. The new compasses' firmware contained a bug that, under very specific conditions, could send an erratic signal causing a spike in power and overall system failure. DJI confirmed both the fault and the bug fix by flying four S800s under heavy burden on electric tether for more than 72 hours without failure.

New GPS Module (NEEDS NEW FACTORY FIRMWARE):

At this point in time DJI would advise that users of large multi-rotors (S800 size and larger) fitted with post-June 15<sup>th</sup> compasses should not fly their multi rotors until their GPS/Compass has been returned for firmware upgrade.

All customers with WooKong-M GPS compasses purchased after June 15th, 2012 should contact their dealer or click [http://www.dji-innovations.com/compass/submit\\_rma/](http://www.dji-innovations.com/compass/submit_rma/) to get information on returning their GPS/Compass module for firmware upgrade.
